INPECT BC

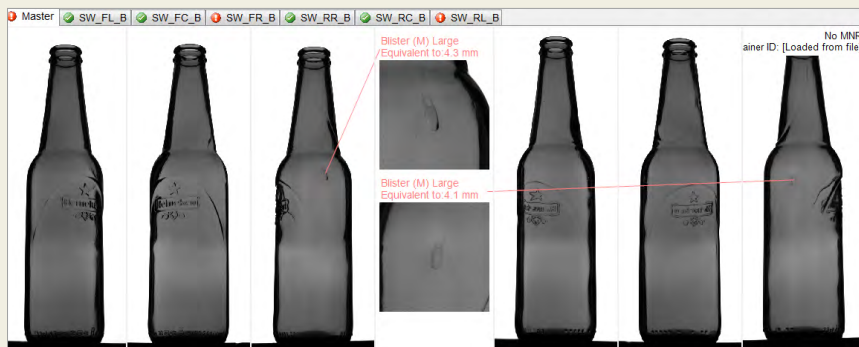
1-

| | stuck glass | >0.6 mm |
| Sidewall area inspection | blemish | |
| | blister | |
| | strong mold seam or wings | |
| | dirt | |
| | black particle | |
| | stone | |
| | visible crack | |
| | strong uneven glass | |

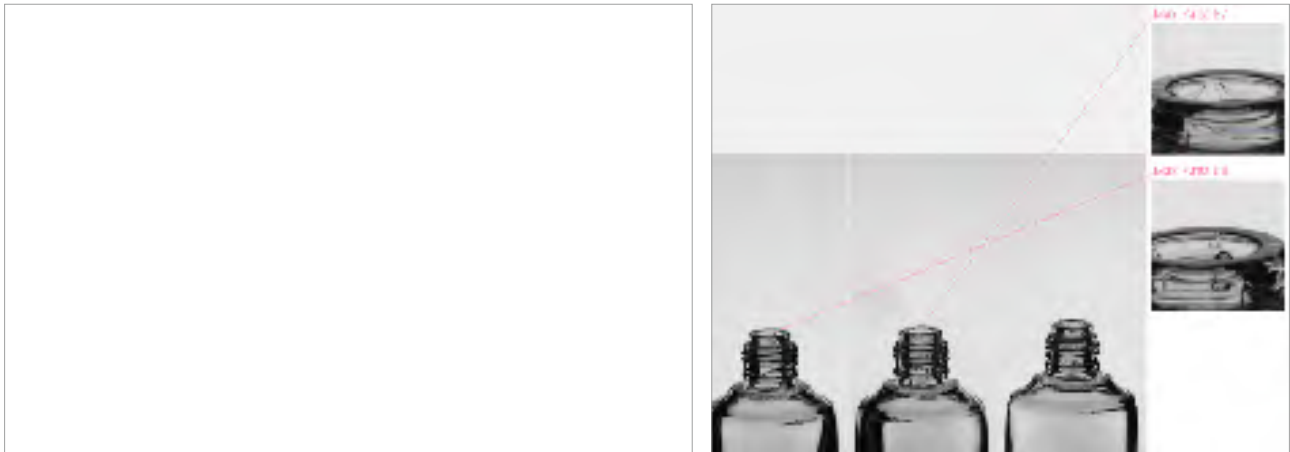
2-

| | defect below sealing | |
| | defect in jar screw | |
| | defect in jar sealing surface | |
